Cetritus Multidisciplinary Journal for Waste Resources & Residues

Architectural report

THE VALUE OF ABANDONMENT: THE GIACOMINI PARK IN ITALY

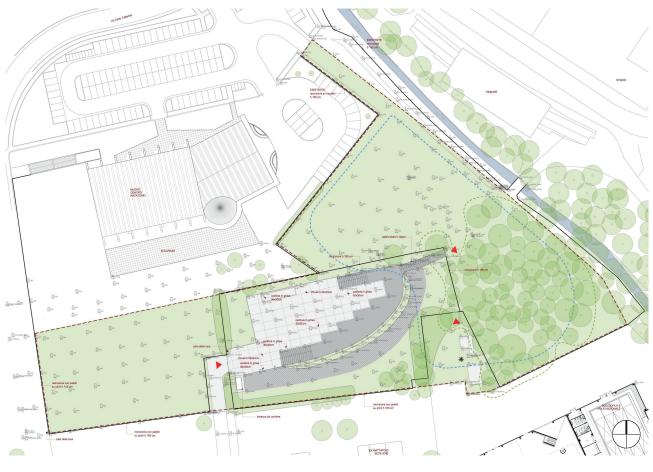
FIGURE 2: General layout of the area of intervention featuring the EFSC area and the section of woodland to the east.

art.183, comma 1, letter cc) of Legislative Decree n.152 dated April 3 2003, which defined the fields of application in municipal or inter-municipal collection centres for household and non-domestic users. Collection centres are made up of a series of removable containers for the conferment of non-hazardous household wastes featuring internal road networks, impermeable paving in the areas for unloading and deposition of wastes, fencing of a height no less than 2m, and an outer barrier of hedging and/or trees or mobile screens to minimize visibility of the facility. The centre includes an area for conferment and deposition on impermeabilized slabs featuring accessible ramps for the conferment of bulky or heavy materials (Figure 2).

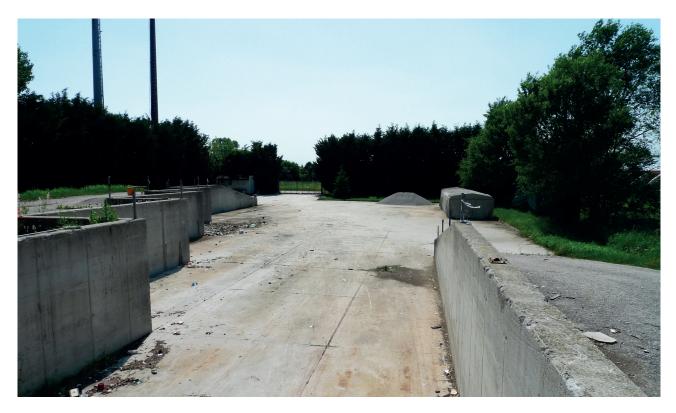
FIGURE 3: Obsolete EFSC.

sitional value, nestled amongst the numerous surrounding activities that constitute a dynamic context (Figure 3).

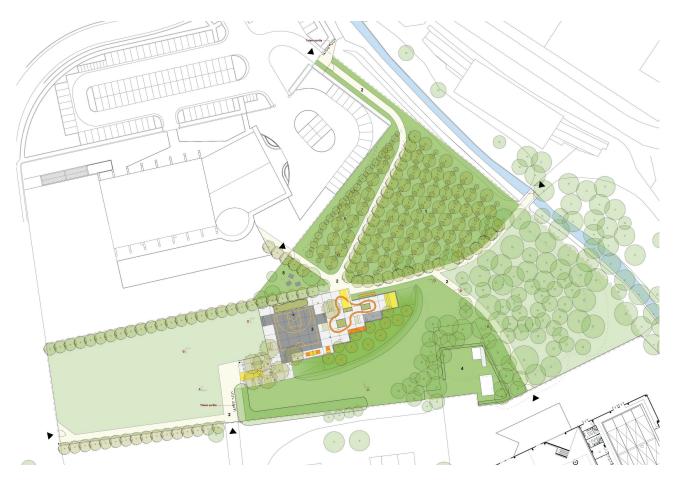
FIGURE 4: General project layout showing the extension of the woodland area, redesign of the road network linking the various areas, and the new function of the EFSC area.

The main works envisaged include (Figure 4):

- Realization of a road network and access system;
- Treatment and erection of masonry and flooring in the area dedicated to games and leisure activities (ex-ESFC);
- Potentiation of vegetation and realization of the woodland.

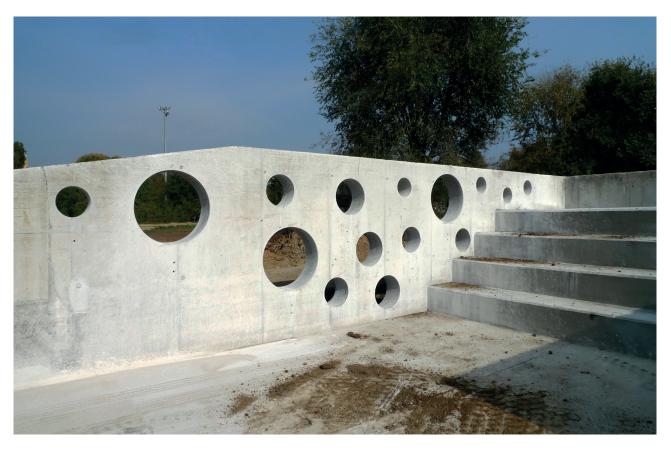
FIGURE 6: Diversified core drilling on the vertical wall.

By manipulating the existing area, sections of concrete were removed to restore permeability to the soil to yield ground on which to plant new trees needed to mitigate the heat, provide shaded spots and constitute areas of collective appeal, design spaces in which to linger, whilst bearing in mind how the soil "is a vital organ to all effects" (Figures 5,6 and 7).

Basic, "circular" actions devised to avoid production of scraps or waste: digging, removing, operating through coring to deform the area, to build the playground, each concrete element cut with precision or deriving from diversified diameter coring was reallocated in the same area to form the basis for a new application - hard paving on which to locate picnic tables or route a brief itinerary. The concrete blocks obtained from cutting of the paving and particularly from coring of the inclined wall, were positioned at varying heights perpendicular to the wall at a point where, due to the presence of surface water, a depression needed reinforcing to ensure stability of the intervention had formed. This particular arrangement was devised to guarantee leaching of surface waters into the concrete slab drainage.

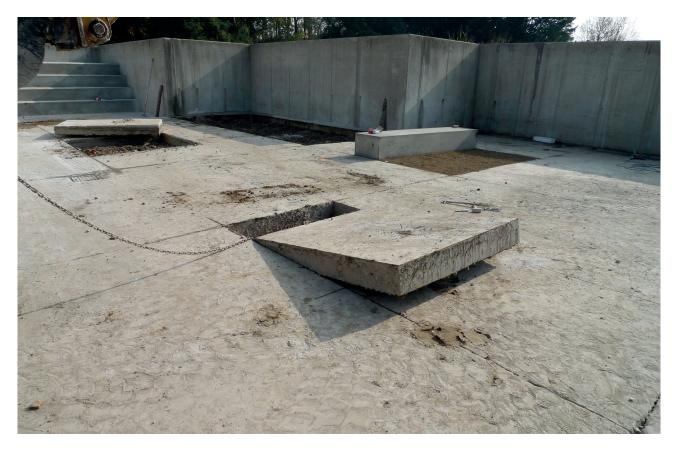
FIGURE 7: Incisions to the ground during recovery of permeable areas.

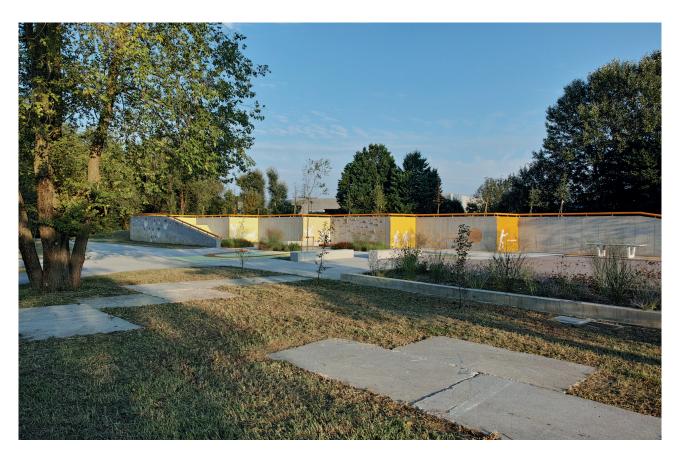
FIGURE 9: View of the intervention in the play area.

A succession of rooms decorated with scenes of shooting, climbing, and street workouts constituted the play area; different colours were applied to mark out space for the specific activities. The floor paving was dyed to create a games itinerary for wheeled vehicles and/or skates, and a basketball court delineated (Figures 8, 9).

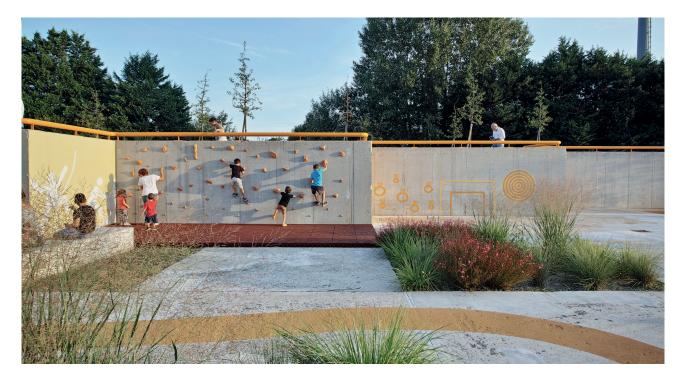
FIGURE 11: Children's climbing wall.

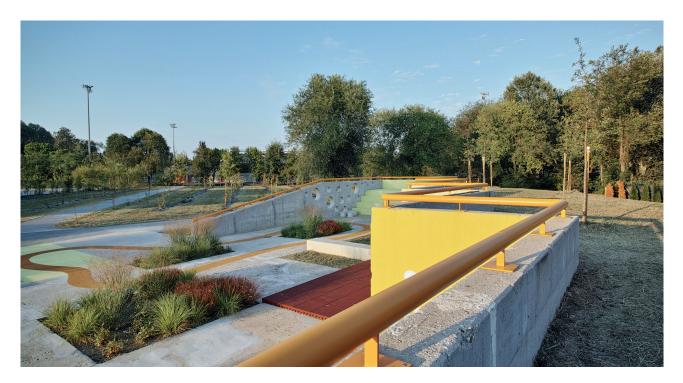
FIGURE 12: View from the top of the embankment towards the regenerated woodlands.

Once freed from the concrete surface as described previously, the large tank that contained the oil drums was covered with cultivated soil and planted with a variety of very low maintenance grasses, including the purple coloured *Perovskia atriplicifolia, Verbena bonariensis, Echinacea purpurea Rubinglow*, and *Eryngium giganteum*, all highly attractive to butterflies and pollinating insects (Figure 12).

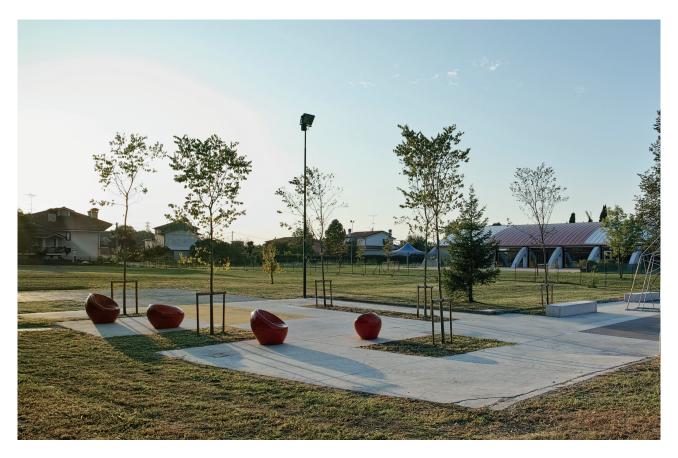
FIGURE 13: Itinerary accessing the sports area.
