WASTE-TO-ENERGY: REUSE OF OIL SPILLED ON THE BRAZILIAN COAST IN 2019 THROUGH CO-PROCESSING

Érica Machado da Silva Guerreiro * and Elisabete de Santis Braga

Oceanographic Institute of the University of São Paulo, IO/USP, Praça do Oceanográfico, 191, Cidade Universitária, Butantã, 05508-120, São Paulo, Brazil

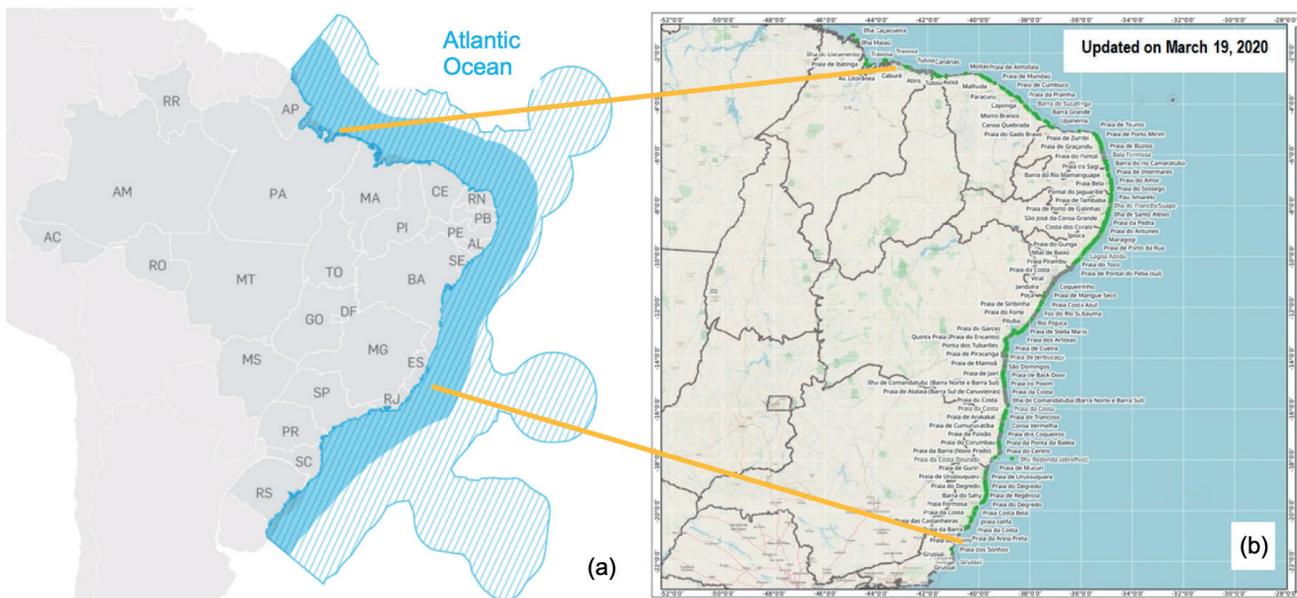
FIGURE 1: (a) Blue Amazon (blue area). Source: IBGE/Estadão; (b) Extent of the oil spill on the Brazilian coast (green area). Source: IBAMA, 2020a.

Figure 1 shows the extent (700 km) of the Brazilian coastal area affected by the oil spill, reaching the northern and northeastern areas, above and below the Equator

due to the bifurcation of the Brazilian Current. This region is an oceanic frontier of the continent, belonging to an area known for its natural riches as the Blue Amazon.

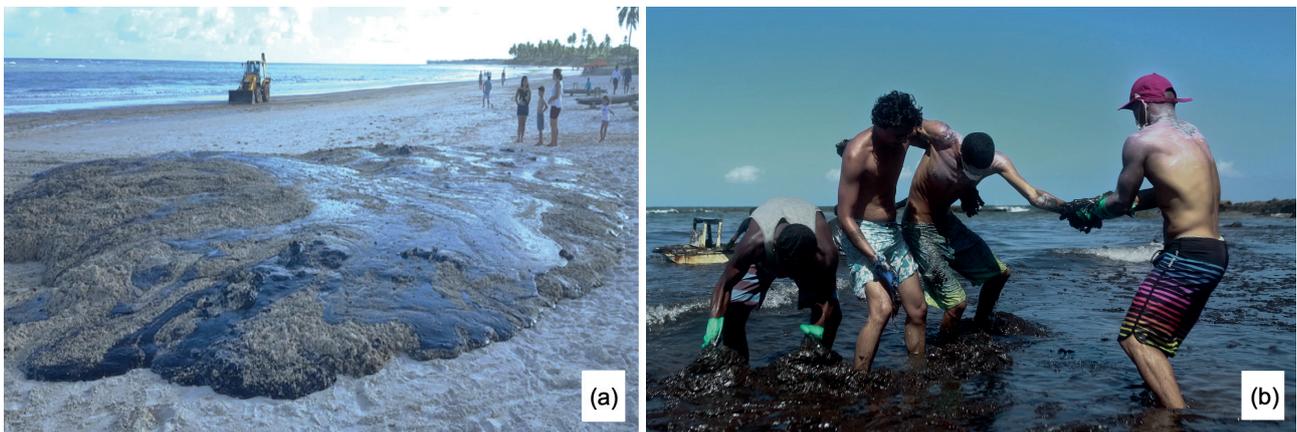
FIGURE 2: (a) Oil spill in Pau Lagoon, in Coruipi (located at Alagoas State), in 2019. Source: MPF, 2025b; (b) Volunteers attempt to rescue young man trapped in the thick layer of oil at Itapuama Beach (located at Pernambuco State). Source: Leo Malafaia/Folha PE, 2019.

According to the Brazilian Institute of Environment and Renewable Natural Resources (IBAMA, 2020b), the oil that reached the Brazilian coast in 2019 (Figure 2) presented high viscosity, high density, and low concentrations of volatile compounds due to the oil quality and weathering. Because of its characteristics, manual removal techniques (using shovels) were used. Visible monitoring sensors did not detect oil slicks, indicating that the oil was not drifting on the sea surface but below the surface, and for this reason it was undetectable by remote observation systems (IBAMA, 2022a).

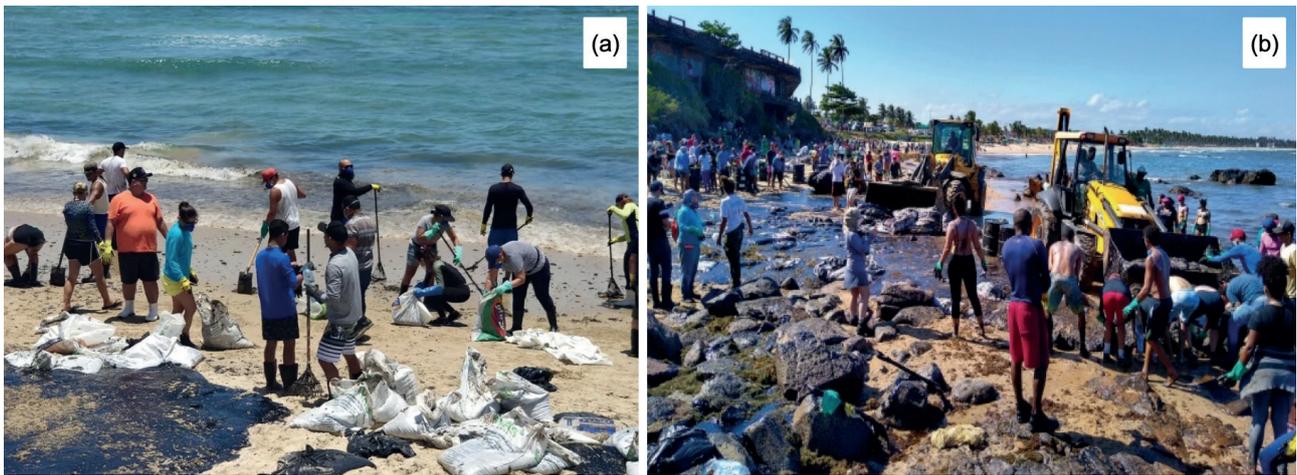
FIGURE 3: . Cleanup carried out by volunteers: (a) Paiva Beach (located in the city of Recife). Source: Oton Veiga/TV Globo, 2019; (b) Itapuama Beach (located at Pernambuco State). Source: Sidney Vieira/Araújo et al, 2020.

It is possible to verify that, even after all the challenges related to storage and logistics costs, most of the oil collected (as shown in Figure 3) on beaches in Northeastern Brazil was reused energetically as an alternative fuel in co-processing industries, instead of being disposed of in landfills without any prior treatment.
