WASTE ARCHITECTURE

FROM A BROWNFIELD TO A RECREATIONAL FACILITY: THE CASE OF THE OLD GABORONE LANDFILL, BOTSWANA

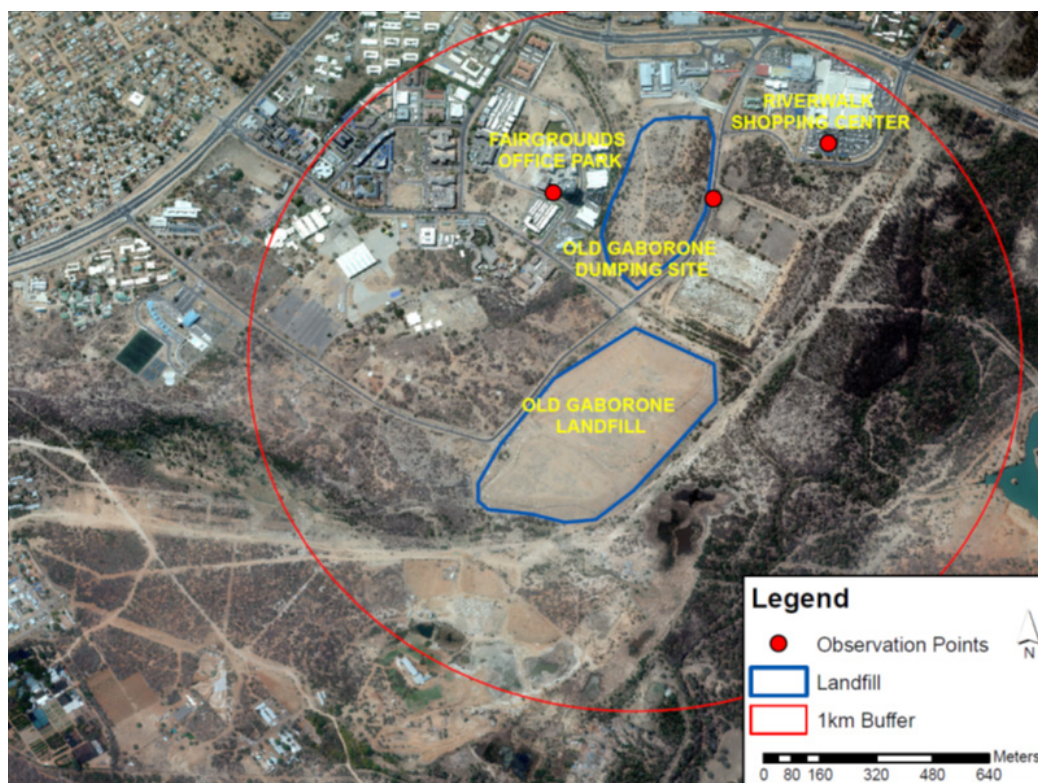
FIGURE 1: Aerial View of Old Gaborone Landfill and Disposal Site.

The old Gaborone landfill in Botswana, is one of such brownfields (see Figure 1). It covers an area of approximately 20 hectares. The landfill was operated beyond its design capacity, hence reaching a maximum elevation of 1018m above sea level. It is sandwiched between an office park to the west – Fairgrounds Office Park, a commercial centre to north – Riverwalk Shopping Centre, Gaborone dam to the south and Notwane River to the east. The landfill is generally barely vegetated. It is visible from most sides of its surrounding developments hence visually intruding them. However, its visual impact from the neighbouring land uses has not been objectively investigated.
